**Flood Control Project Maintenance  
Levee Inspections**

## Maintenance Issue Types Only, Levee Inspection Report By Mile - Fall 2016

### Reclamation District No. 2085 Kasson

Waterway	Bank	Unit Miles	Inspection Start/End	Inspector
Unit No. 01 San Joaquin River	Left	5.29	10/19/2016 10/19/2016	Maksim Khashchuk

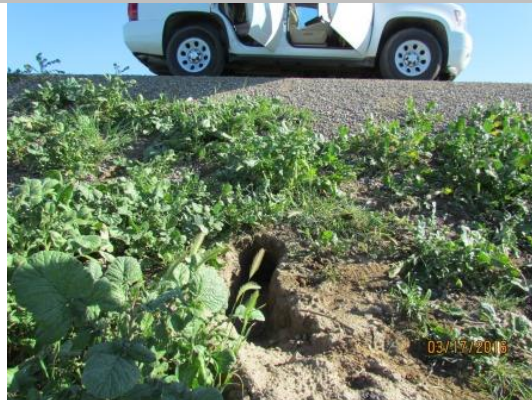
Photo 1 of 1 : FA\_2016\_RD2085\_113\_39\_20160914\_00016.jpg

LM Start	1.79	Rating **	M	Issue No.	39
LM End	1.79	Issue Type +	Ma	Location *	WS
Category	Earthen Levee			GPS Latitude/Longitude	
				Start	End
Item	Animal Control			37.711456 °	37.711456 °
				-121.282397 °	-121.282397 °
DWR ID	DWR_RD2085_01_s_2016_39				
Comment Code					
A3 : No rodents visible, but rodent burrows visible; need to backfill and compact or grout burrows.					
Inspector Comment					
LMA has bait stations on the levee.

View of the rodent burrows on the landside levee slope.

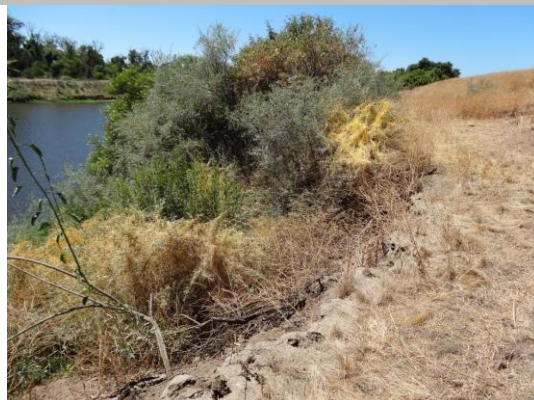
Photo 1 of 3 : SJR2016\_RD2085U01RM66.5\_1.jpg

Close view of the erosion.

07/08/2016: No significant change observed.

09/10/2015: No significant change observed. Signs of animal activity are present.

09/10/2014: No significant change observed.

09/20/2013: No significant change in erosion observed. More vegetation at the site.

12/04/2012: The erosion has progressed remarkably toward levee, extended to the up-and downstream of the original pocket erosion. Trees and dense bush are present at the site. Animal burrow holes are visible, and possibly can cause seepage.

09/22/2010: No significant change observed. There is little visibility due to seasonal grass on the berm and slope.

08/18/2009: Site is located on berm; pocket erosion has developed; the site is covered in dense vegetation; there are several relief wells on the landside of the levee; site is Not Rated because berm width is greater than 30 feet; site should be monitored to keep track of erosion progress. [2016 Site ID:RD2085U01RM66.5]

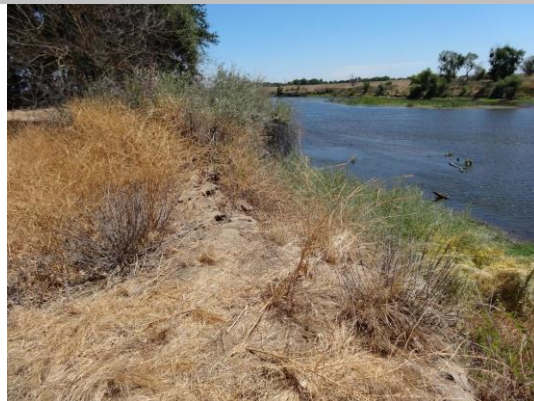
Photo 2 of 3 : SJR2016\_RD2085U01RM66.5\_3.jpg

Direct view of the erosion. Note the dense vegetation at the site.

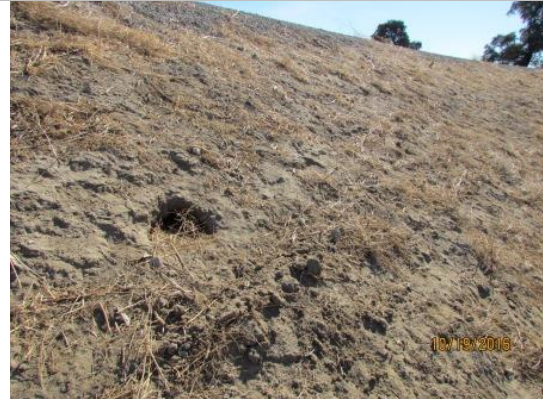
Photo 1 of 2 : FA\_2016\_RD2085\_113\_45\_20161024\_00050.jpg

LM Start	3.57	Rating **	M	Issue No.	45
LM End	3.57	Issue Type +	Ma	Location *	LS
Category	Earthen Levee			GPS Latitude/Longitude	
				Start	End
Item	Animal Control			37.690161 °	37.690161 °
				-121.276543 °	-121.276543 °
DWR ID	DWR_RD2085_01_s_2016_45				
Comment Code					
A3 : No rodents visible, but rodent burrows visible; need to backfill and compact or grout burrows.					
Inspector Comment

View of the rodent burrows on the landside levee slope. Fall 2016

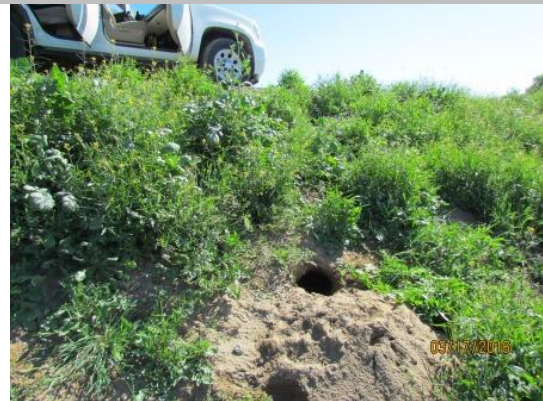
Photo 2 of 2 : FA\_2016\_RD2085\_113\_45\_20160914\_00018.jpg

View of the rodent burrows on the landside levee slope.

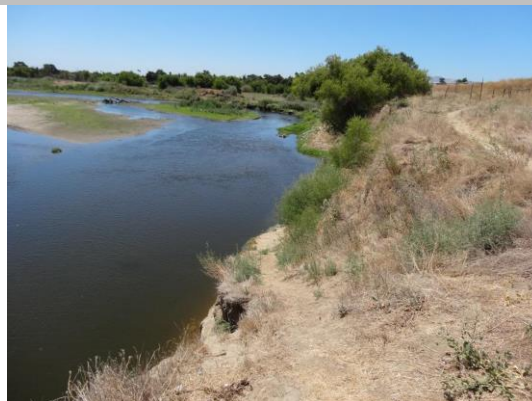
Photo 1 of 3 : SJR2016\_RD2085U01RM67.7\_1.jpg

07/08/2016: The erosion in the berm was found slightly progressed toward the levee toe. Signs of fresh erosion at the site are visible.  
 08/19/2015: No significant change observed.  
 07/17/2014: No significant change observed.  
 09/10/2013: No significant change observed.  
 12/04/2012: This site has been documented before, and a cost estimate to repair has been prepared dated 05/09/2010. The fresh cut shows the erosion is developing. The berm width is at least 42 feet. Sticks were placed at three locations along the river bank, with 3 sticks 5 feet apart at each location. [2016 Site ID:RD2085U01RM67.7]

View of the downstream end of the erosion.

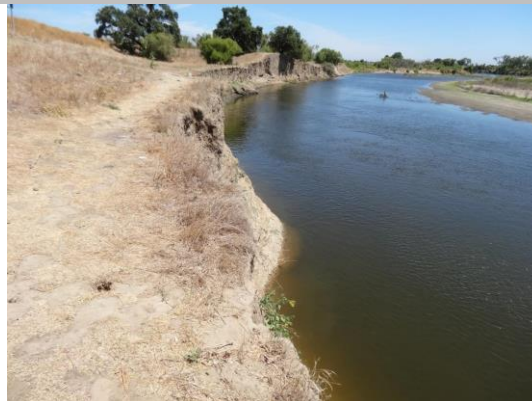
Photo 2 of 3 : SJR2016\_RD2085U01RM67.7\_2.jpg

Close view of the erosion.

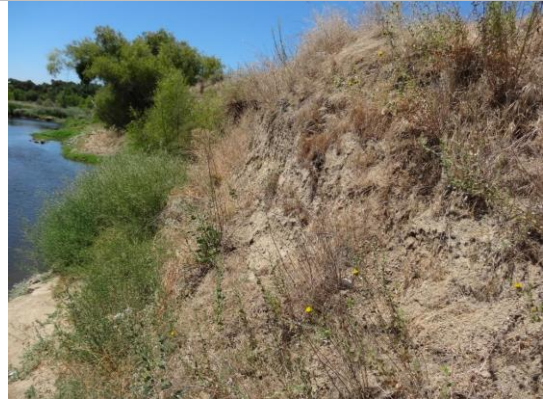
Photo 3 of 3 : SJR2016\_RD2085U01RM67.7\_4.jpg

Close view of the erosion.

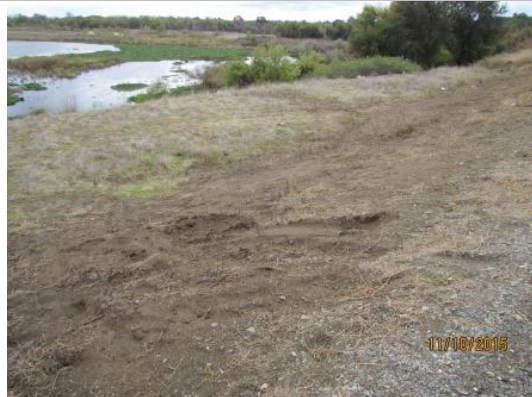
Photo 1 of 1 : FA\_2016\_RD2085\_113\_25\_20160914\_00009.jpg

LM Start	3.71	Rating **	A/W	Issue No.	25
LM End	3.71	Issue Type +	Ma	Location *	WS
Category	Earthen Levee			GPS Latitude/Longitude	
				Start	End
Item	Slope Stability			37.688216 °	37.688216 °
				-121.276603 °	-121.276603 °
DWR ID	DWR_RD2085_01_f_2015_25				
Comment Code					
S3 : Repair the levee slope damaged by vehicle traffic and prevent access where possible.					
Inspector Comment					
Control levee access to prevent damage to levee slopes by vehicle.

View of the waterside levee slope damaged by vehicle.

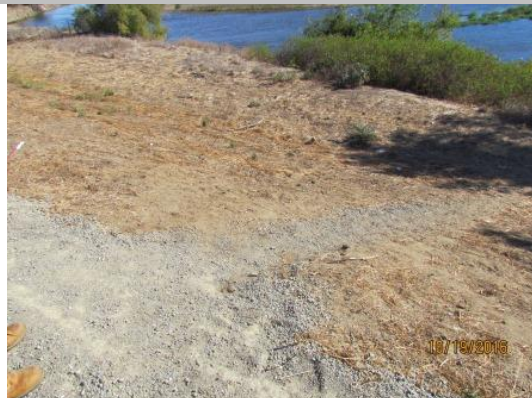
Photo 1 of 1 : FA\_2016\_RD2085\_113\_26\_20161024\_00049.jpg

LM Start	3.74	Rating **	A/W	Issue No.	26
LM End	3.74	Issue Type +	Ma	Location *	WS
Category	Earthen Levee			GPS Latitude/Longitude	
				Start	End
Item	Slope Stability			37.687841 °	37.687841 °
				-121.276678 °	-121.276678 °
DWR ID	DWR_RD2085_01_f_2015_26				
Comment Code					
S2 : Repair the levee slope damaged by foot traffic and prevent access where possible.					
Inspector Comment					
Area should be maintained to prevent further levee damage.

View of the foot path on the levee slope.

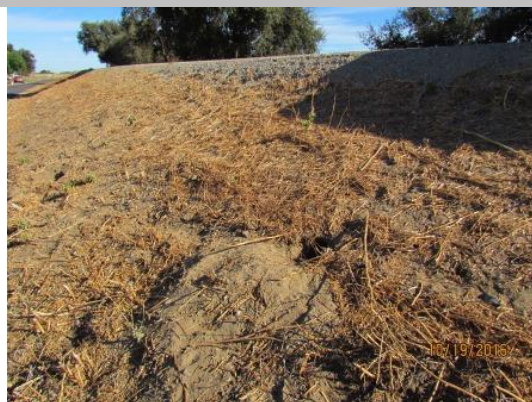
Photo 1 of 1 : FA\_2016\_RD2085\_113\_36\_20161024\_00048.jpg

LM Start	3.86	Rating **	M	Issue No.	36
LM End	3.91	Issue Type +	Ma	Location *	LS
Category	Earthen Levee			GPS Latitude/Longitude	
				Start	End
Item	Animal Control			37.686059 °	37.685340 °
				-121.276745 °	-121.276594 °
DWR ID	DWR_RD2085_01_f_2016_36				
Comment Code					
A3 : No rodents visible, but rodent burrows visible; need to backfill and compact or grout burrows.					
Inspector Comment

View of the rodent holes on the levee slope.

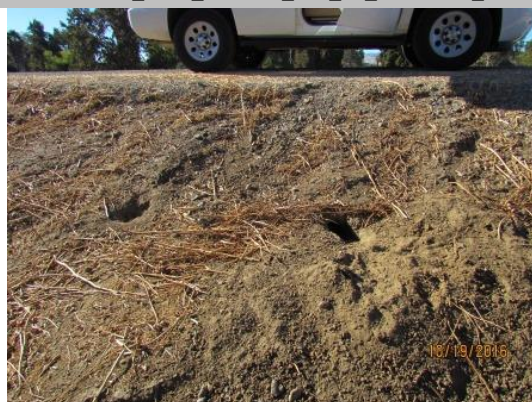
Photo 1 of 1 : FA\_2016\_RD2085\_113\_34\_20161024\_00047.jpg

LM Start	4.15	Rating **	M	Issue No.	34
LM End	4.15	Issue Type +	Ma	Location *	WS
Category	Earthen Levee			GPS Latitude/Longitude	
				Start	End
Item	Animal Control			37.682495 °	37.682495 °
				-121.274169 °	-121.274169 °
DWR ID	DWR_RD2085_01_f_2016_34				
Comment Code					
A3 : No rodents visible, but rodent burrows visible; need to backfill and compact or grout burrows.					
Inspector Comment

View of the rodent holes on the levee slope.

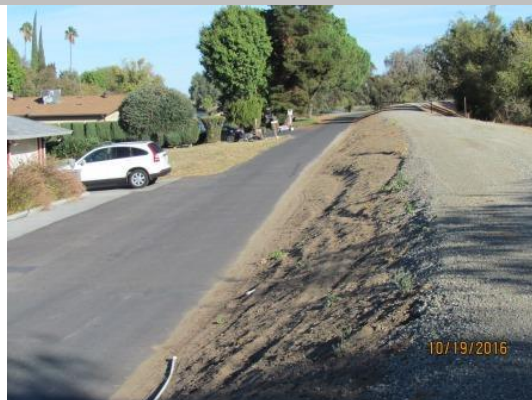
Photo 1 of 1 : FA\_2016\_RD2085\_113\_52\_20161024\_00044.jpg

LM Start	5.20	Rating **	M	Issue No.	52
LM End	5.20	Issue Type +	Ma	Location *	LS
Category	Earthen Levee			GPS Latitude/Longitude	
				Start	End
Item	Slope Stability			37.675620 °	37.675620 °
				-121.269359 °	-121.269359 °
DWR ID	DWR_RD2085_01_s_2016_52				
Comment Code					
S3 : Repair the levee slope damaged by vehicle traffic and prevent access where possible.					
Inspector Comment

View of the tire tracks on the levee slope.

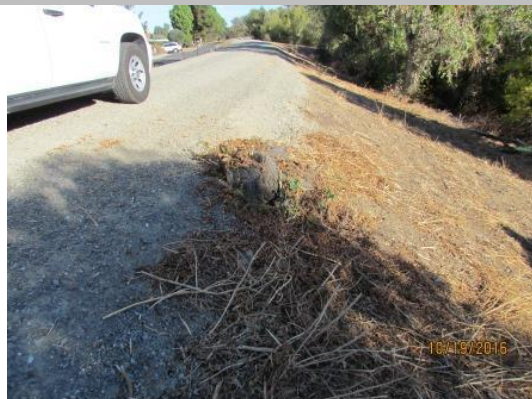
Photo 1 of 1 : FA\_2016\_RD2085\_113\_29\_20161024\_00043.jpg

LM Start	5.24	Rating **	N	Issue No.	29
LM End	5.24	Issue Type +	Ma	Location *	WS
Category	Earthen Levee			GPS Latitude/Longitude	
				Start	End
Item	Trim / Thin Trees			37.675099 °	37.675099 °
				-121.269264 °	-121.269264 °
DWR ID	DWR_RD2085_01_f_2015_29				
Comment Code					
T5 : Tree stumps.					
Inspector Comment

View of the tree stump.

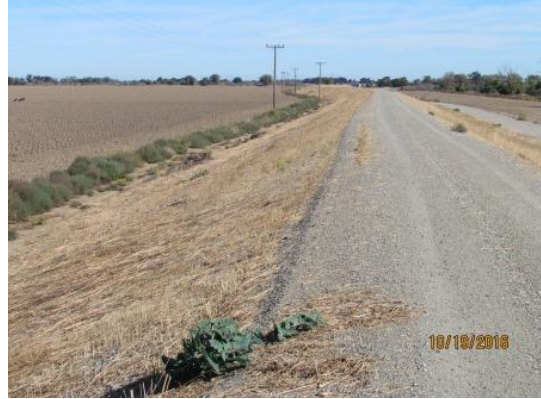
Photo 1 of 1 : FA\_2016\_RD2085\_114\_1\_20161024\_00001.jpg

LM Start	0.02	Rating **	A	Issue No.	1
LM End	0.69	Issue Type +	Ma	Location *	WS
Category	Earthen Levee			GPS Latitude/Longitude	
				Start	End
Item	Vegetation			37.705041 °	37.714004 °
				-121.274570 °	-121.269690 °
DWR ID	DWR_RD2085_02_f _ 2016_1				
Comment Code					
V1 : Control annual grass and weeds on the levee slopes and easements.					
Inspector Comment					
LMA has good vegetation control this season.

View of the well maintained vegetation on the levee slope.

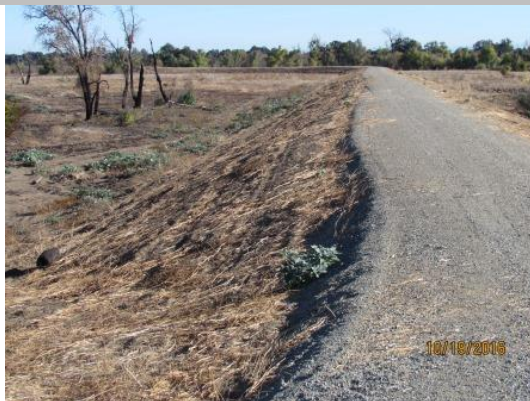
Photo 1 of 1 : FA\_2016\_RD2085\_115\_4\_20161024\_00002.jpg

LM Start	0.01	Rating **	A	Issue No.	4
LM End	0.01	Issue Type +	Ma	Location *	WS
Category	Earthen Levee			GPS Latitude/Longitude	
				Start	End
Item	Vegetation			37.680574 °	37.680574 °
				-121.264585 °	-121.264585 °
DWR ID	DWR_RD2085_03_f_2016_4				
Comment Code					
V1 : Control annual grass and weeds on the levee slopes and easements.					
Inspector Comment					
LMA did a great job controlling the vegetation this season.

View of the well maintained vegetation on the levee slope.

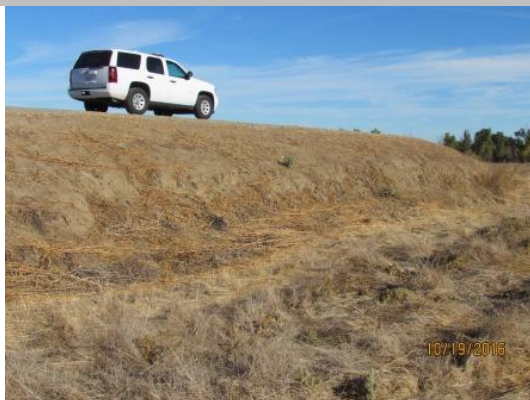
Photo 1 of 2 : FA\_2016\_RD2085\_115\_1\_20161024\_00003.jpg

LM Start	0.21	Rating **	U	Issue No.	1
LM End	0.23	Issue Type +	Ma	Location *	WS
Category	Earthen Levee			GPS Latitude/Longitude	
				Start	End
Item	Erosion / Bank Caving			37.682798 °	37.683052 °
				-121.262059 °	-121.261851 °
DWR ID	DWR_RD2085_03_s_2014_1				
Comment Code					
E2 : Schedule repair of erosion site prior to the next inspection.					
Inspector Comment					
Erosion of the waterside levee slope has been observed. The erosion is about 3 feet tall vertical from the slope to the base of projected levee toe.

View of the erosion at the waterside levee toe. Fall 2016.

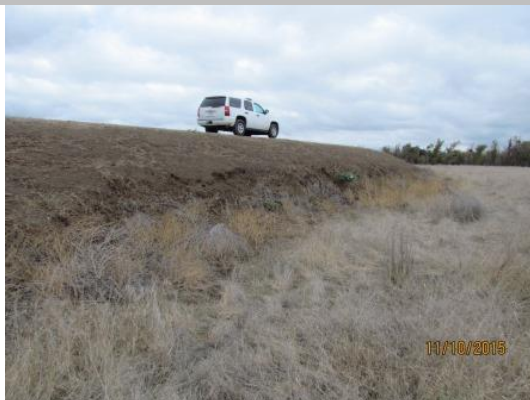
Photo 2 of 2 : FA\_2016\_RD2085\_115\_1\_20160914\_00001.jpg

View of the erosion at the waterside levee toe.

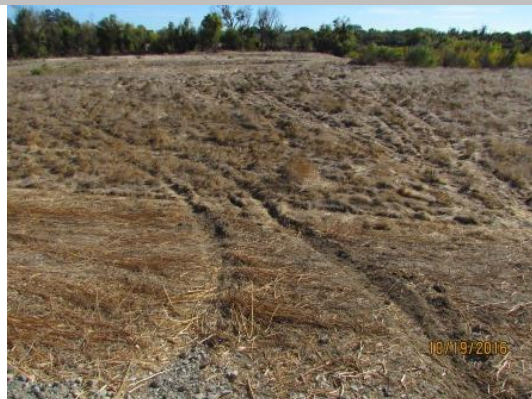
Photo 1 of 1 : FA\_2016\_RD2085\_115\_7\_20161024\_00004.jpg

LM Start	0.25	Rating **	M	Issue No.	7
LM End	0.25	Issue Type +	Ma	Location *	WS
Category	Earthen Levee			GPS Latitude/Longitude	
				Start	End
Item	Slope Stability			37.683274 °	37.683274 °
				-121.261839 °	-121.261839 °
DWR ID	DWR_RD2085_03_f_2016_7				
Comment Code					
S3 : Repair the levee slope damaged by vehicle traffic and prevent access where possible.					
Inspector Comment

View of the tire tracks on the levee slope.
